POPPLETON HISTORIC STUDY

1215 W. Saratoga Street

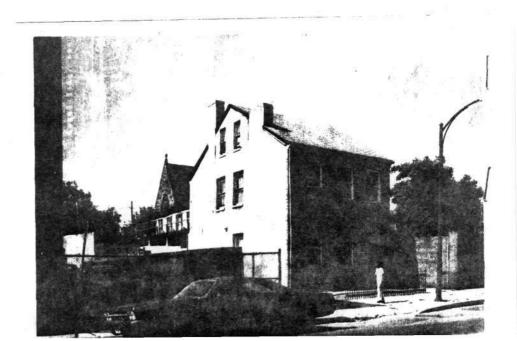
The 1851 map shows a building set back from Saratoga Street at this point in the block. The gable roof, promenade porch, double dormers on the back, and extended back building of this house would also suggest an early date. The house is formstoned but in good condition. Cast iron fence may be original, as is probably the stone wall which runs all the way back to Rankin Place. This building should be retained, preferably with the formstone removed.

Situated on a busy two-way street where street trees are needed; isolated by Hebrew Cemetery to west and old schoolyard to east. The form and scale of the structure are strong enough to stand alone.
